Technical Service Bulletin

GROUP RECALL	NUMBER 16-01-030-1
DATE JULY, 2016	MODEL(S) SONATA (YF)

SUBJECT: YF SONATA MOTOR DRIVEN POWER STEERING
(MDPS) / MDPS ECU REPLACEMENT (RECALL CAMPAIGN 143)

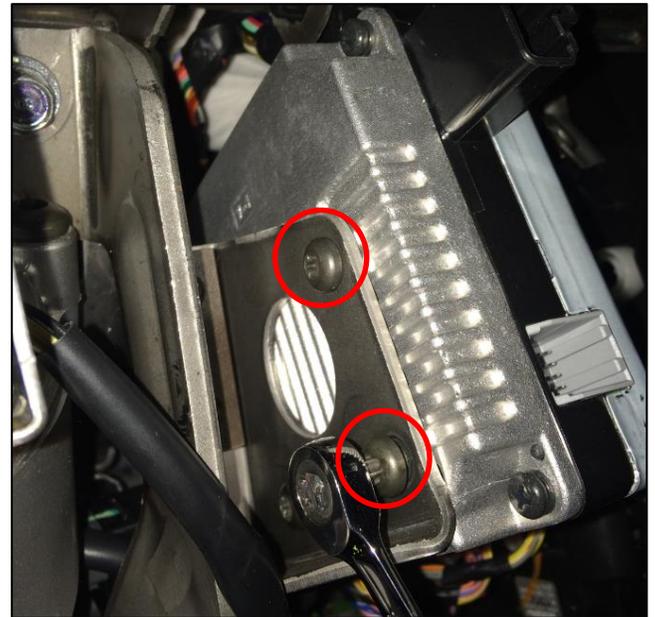
8. Remove the 2 circled Torx bolts mounting the ECU to the bracket using the SST.

The SST has a ratcheting mechanism. One side is for tightening, one side is for loosening.

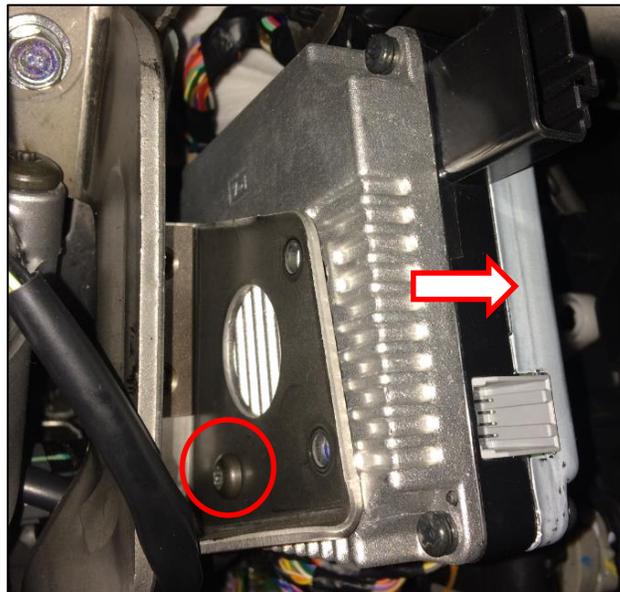
9. Remove the remaining 3rd Torx bolt.

Completely remove the two bolts closest to the driver before loosening the third bolt (circled).

This will provide more clearance to remove the third bolt by allowing the ECU body to be moved off of the mounting bracket as the bolt is loosened.

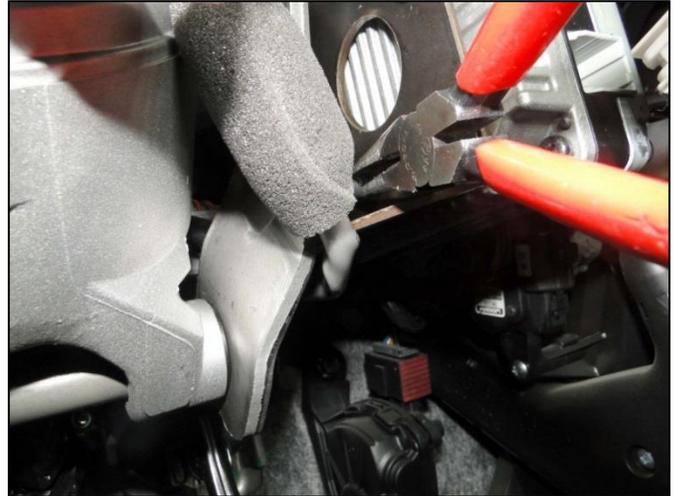
12. With the two bolts holding the ECU in place, insert the remaining Torx bolt using a pair of long nose pliers.

Lightly tighten all 3 Torx bolts using the SST until hand-tight. Then, turn the 3 bolts an additional 30 degrees using the SST.
